Request for Proposal #21-37333
Sportspark Renovation Multi-Phase
Project ADDENDUM #04

LIMITED ASBESTOS INSPECTION REPORT

250 Main Street,
New York, NY 10024

Project No.: 19-5545

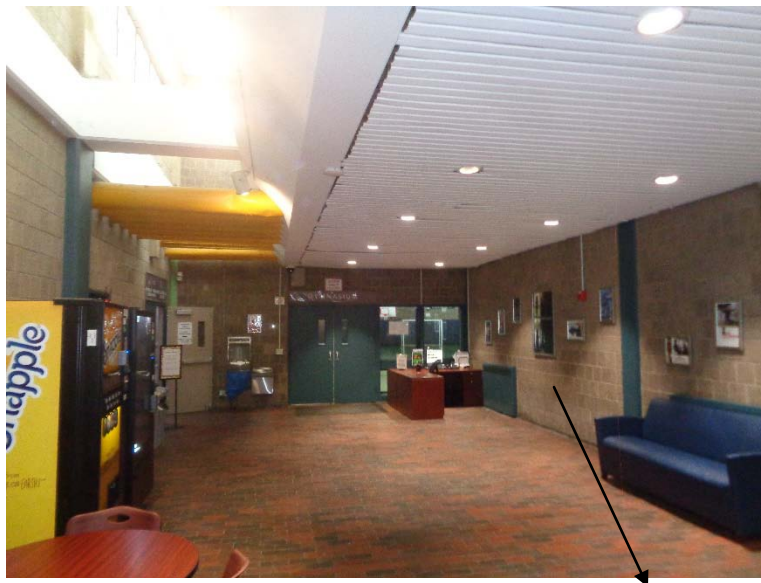
View of 1st Floor/ Sportspark Lobby Lower West (Brick-Mortar)

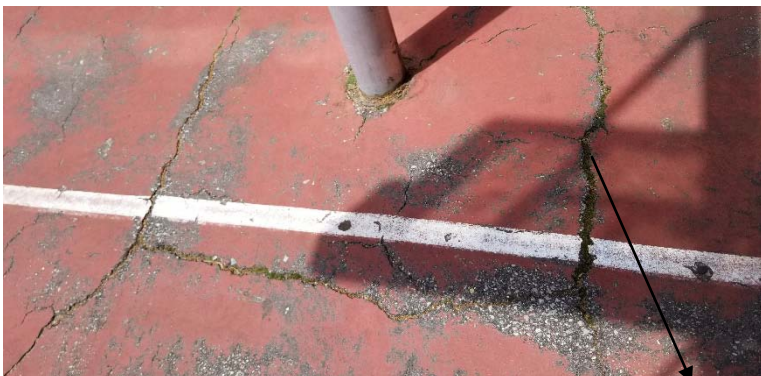
View of 1st Floor/ Sportspark External Basketball Court (FloorConcrete)

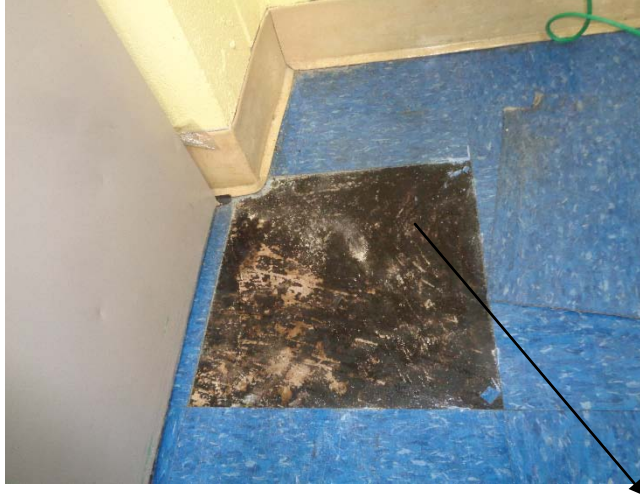
View of 1st Floor/ Sportspark Manager Office (12x12 Vinyl Floor Tile & Floor Mastic)

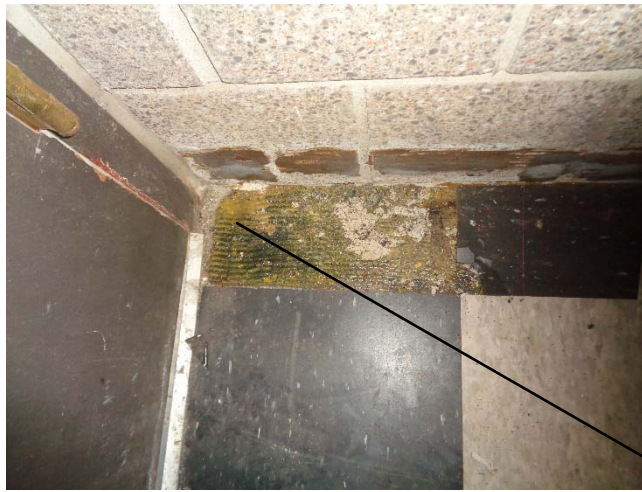
View of 1st Floor/Sportspark Hallway by Steam Equipment (12x12 V.F.T Black/White & Floor Mastic)

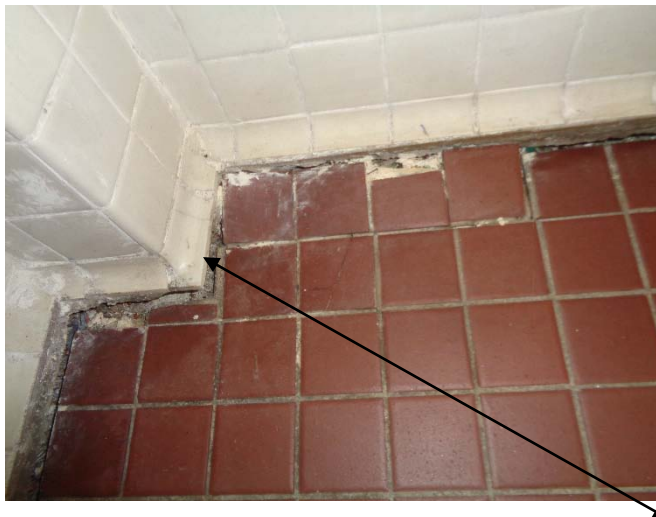
View of 1st Floor/ Sportspark West Side Men's Restroom (Floor Grout)

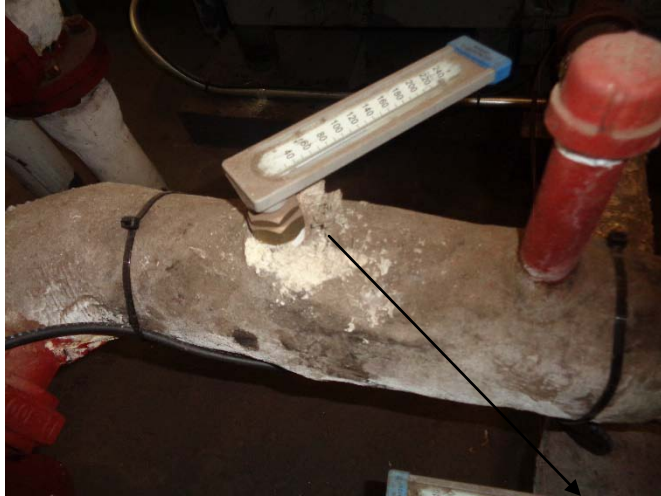
Sample #	Homogeneous Sampling Area	Material & Color	Sample Location	Number of Bulk Samples Collected	Asbestos Detected?	Quantity (Approximately*)
023	I	Elbow Insulation, Gray	Floor 2/ Sportspark/ West Side H & V Room	3	Yes	60 SF
024						
025						
	N/A	Elbow Insulation	Floor 1/ Various Locations		Yes Assumed	90 SF

View of 2nd Floor/ Sportspark West Side H7V Room (Elbow Insulation)

All ACM that will be impacted by any proposed renovation should be removed prior to the start of work. Section 56-5, Subpart 1(h) of the New York State Department of Labor Industrial Code Rule 56 Asbestos Regulations states that:

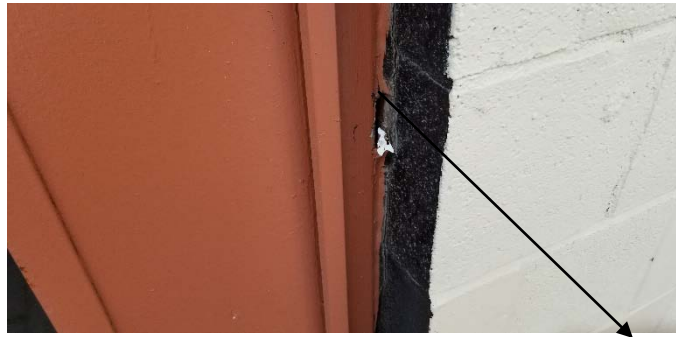
View of 1st Floor/ Sportspark West Side Main Entrance (Door Caulk)

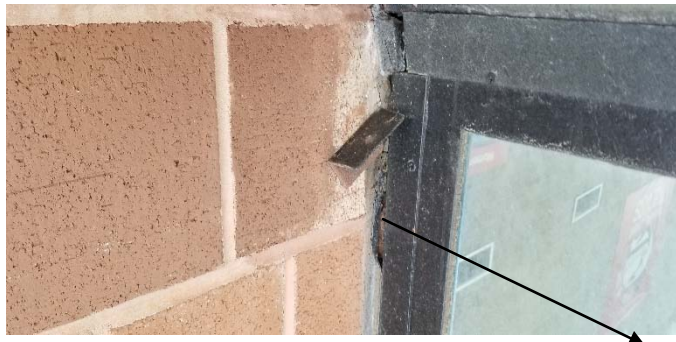
View of 1st Floor/ Sportspark Exterior Façade South Side (Window Caulk)

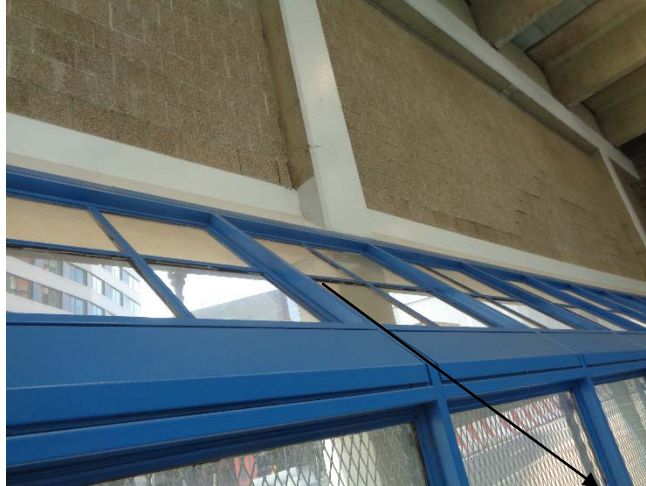
View of 1st Floor/ Sportspark Skylight by Pool Area (Muntin Caulk)

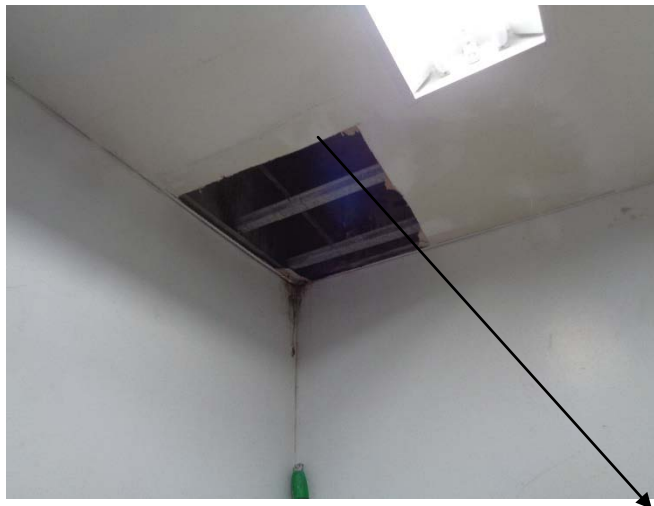
View of 1st Floor/ Sportspark West Side Equipment Storage (Dry Ceiling)

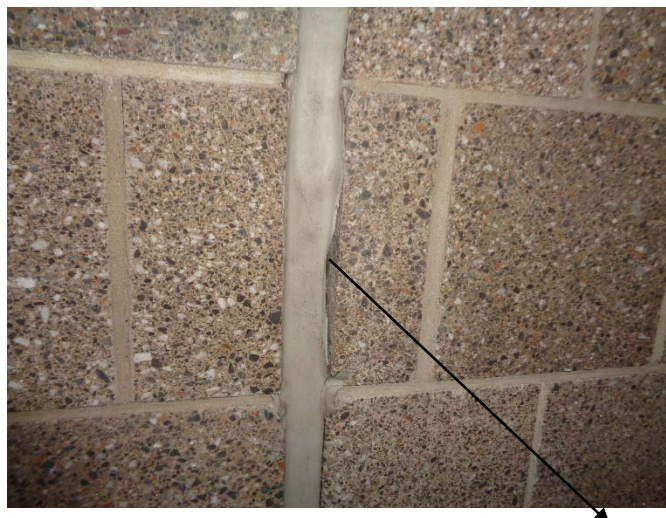
View of 1st Floor/ Sportspark East Side Corridor (5) (Perimeter Caulk)
